RULES FOR APPROVAL OF MANUFACTURERS AND SERVICE SUPPLIERS

Rules for Approval of Manufacturers and Service Suppliers
2009 AMENDMENT NO.1

AMENDMENT TO THE RULES FOR APPROVAL OF MANUFACTURERS AND SERVICE SUPPLIERS

**BALLAST TANK COATING TEST OF 2 * 160 μ M EXAMPLE EPOXY PAINT
ON EXAMPLE SHOP PRIMER**

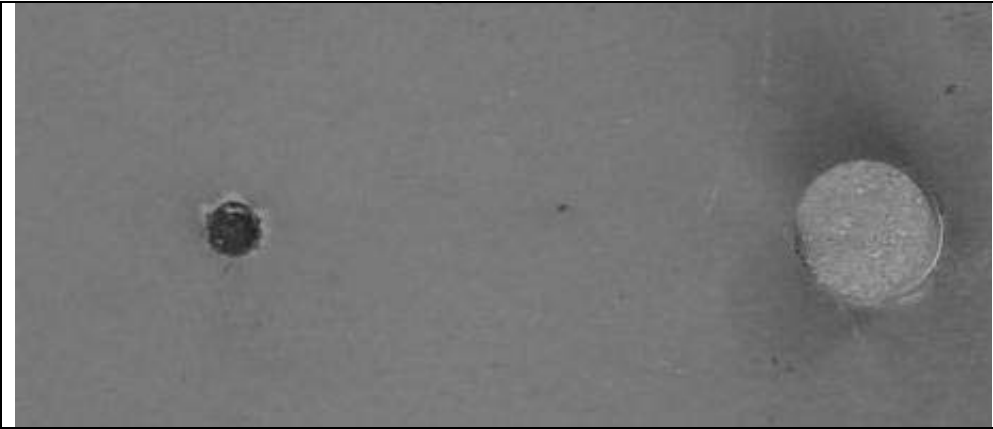
Figure C-2 Disbonding from artificial holiday, bottom wave tank panel (example picture not connected to example results in this model report).
